## **TECHNICAL SUPPORT AND TRAINING QUARTERLY INFORMATION REVIEW**

### **CIS Technical Call Centre**

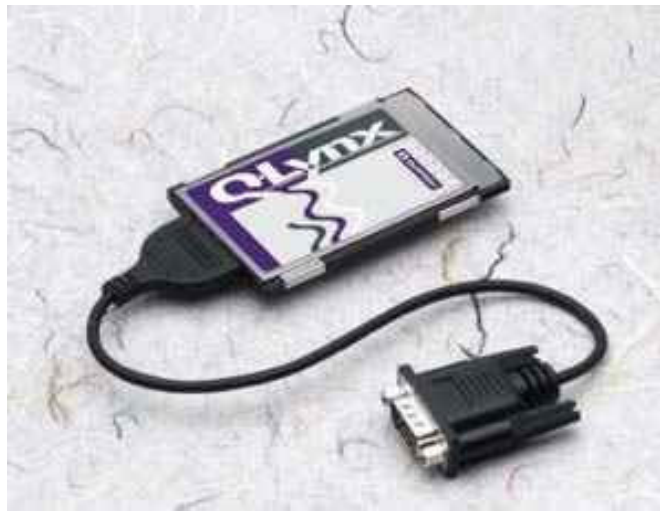
We have had some difficulties in the release of Laptop's without any RS232 ports. The best solution that we have found is a single port PCMCIA toRS232 card that will suit any type II PCMICA slot. It will operate under all operating systems, it worked well with both C-Bus and Home Minder, and it is easy to install and appears to have no conflicts. On most Laptop configuration's it will install as COM 2 to COM 4 as long as nothing else is using these settings. Details of this device are

Portability: **Unit is the size of a credit card and comes with a protective casing.**
